**UTILIZATION OF COCONUT LUMBER FOR FURNITURE  
MANUFACTURE (CLASSROOM CHAIRS)**

Arnaldo P. Mosteiro<sup>1</sup>

### ABSTRACT

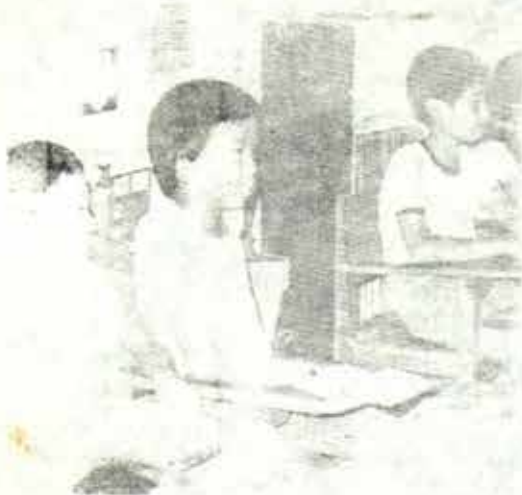
Experimental chairs undergoing actual service test in public elementary schools.

The service-testing and inspection phase will be covered by a separate study proposal and will be conducted as a regular project of FPRDI. Individual specimens will be inspected annually during the first 5 years and a semi-annual inspection during the succeeding years. A technical report on the conditions of the chairs will be prepared after every inspection.
